## Reference number(s): 15G6

Non-concentric engine running  
Noises in the engine region

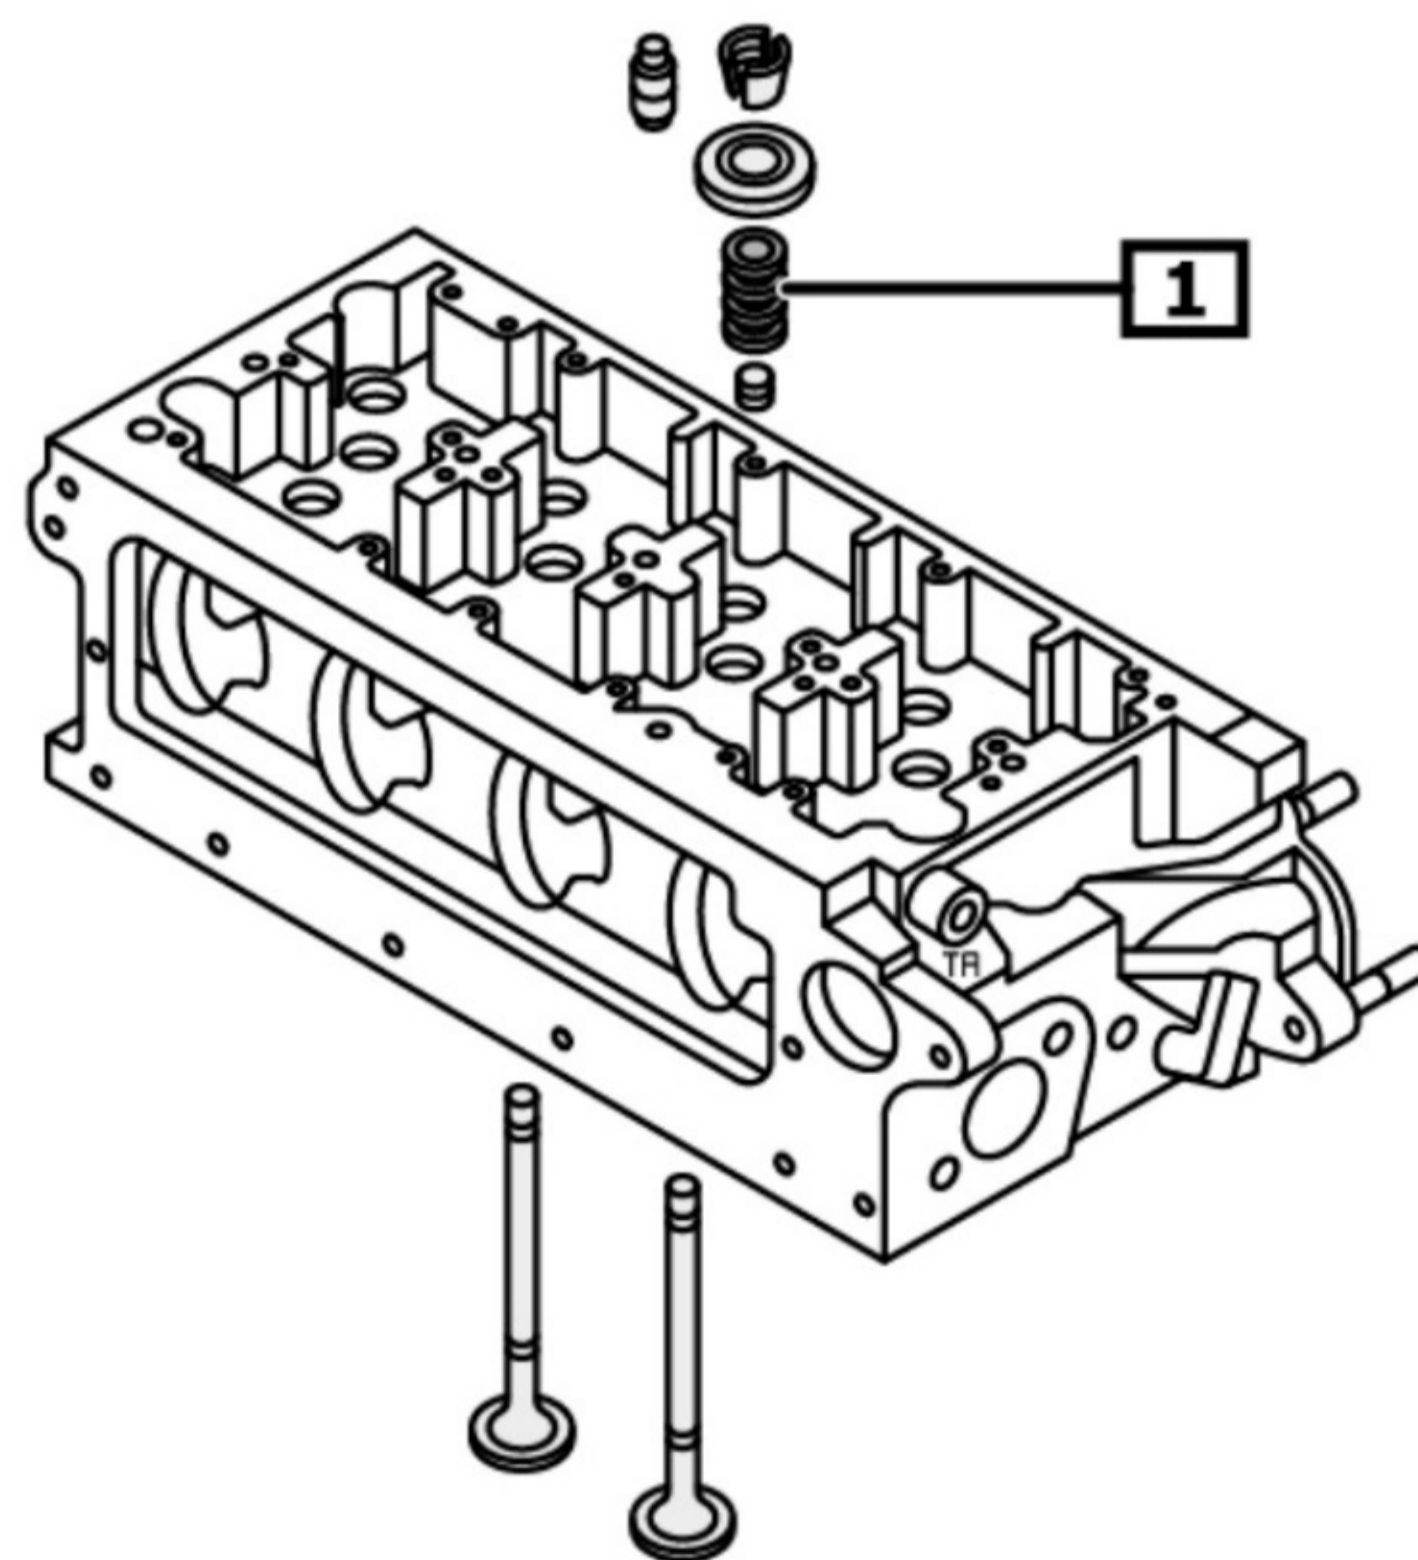
Figure

Low-quality valve springs have been installed.

1 Valve spring(s)

Replace valve spring(s). [1]  
(see figure)
