Possible reasons for warping and bending strain in the shock absorber

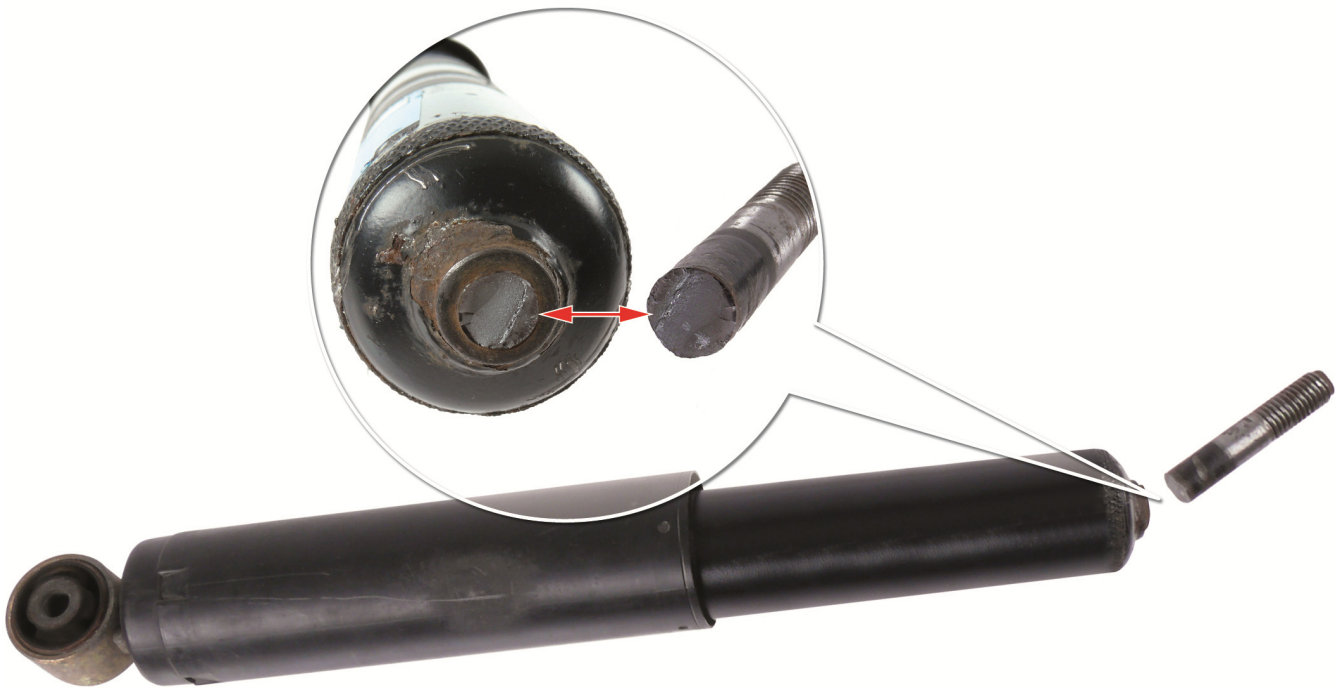
Fig. 1: Pin joint broken due to changing bending strain

- Assembly error: Shock absorber installed in warped position, i.e. not tightened in the design position.
- Attachment points in the shock absorber are not flush.

1. Check vehicle for accident damage and other damage.
2. Install shock absorbers in the raised vehicle and screw in **manually**.
3. Lower the vehicle so that it is resting on its wheels (design position).
4. Tighten the screws to the tightening torque recommended by the vehicle manufacturer.

Tighten the shock absorbers in the vehicle design position recommended by the vehicle manufacturer using the recommended tightening torque.

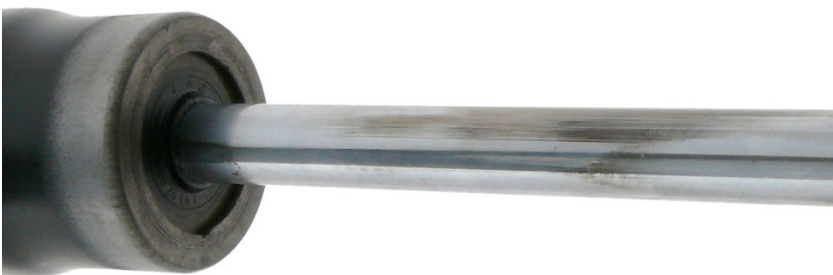
Fig. 2: Chrome layer of the piston rod worn out on one side due to warped installation
