STEYR Series 80 tractor

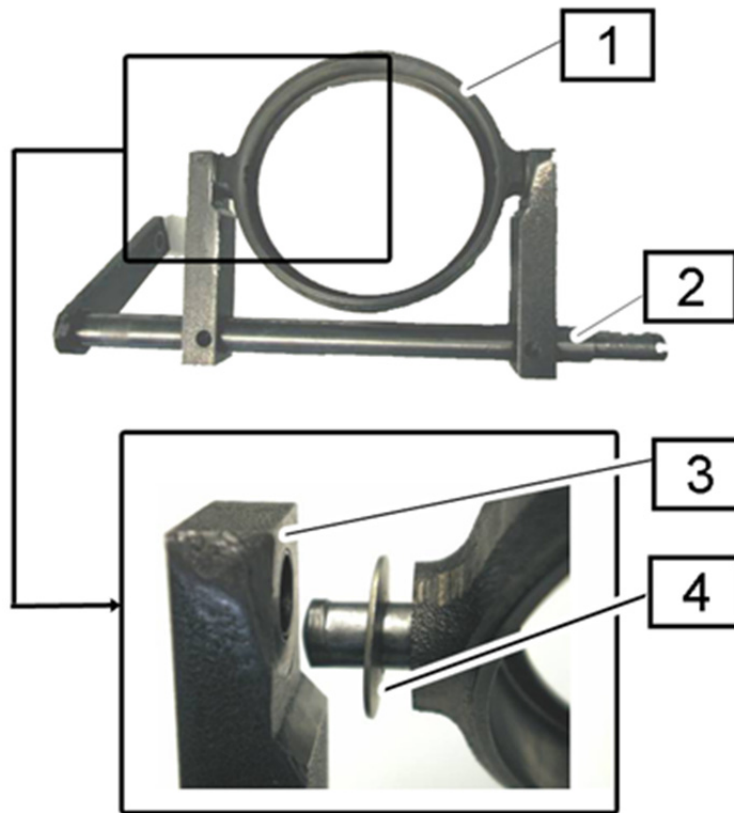
Fig. 1: The power take-off clutch does not release – causing noise

Severe wear of bearings, bushes, lever arms and shafts, result in an inclination and tilting of the power take-off release mechanism. Uneven lifting of the pressure plate causes noise, hinders release, and in extreme cases, fracture of the release bearing bracket (1).

This can result in damage to the clutch also causing consequential damage to components surrounding the clutch assembly

If the release bearing tilts during operation, this indicates wear. In such cases the following parts should be replaced, at the very least:

Every time you replace a clutch assembly, check the entire release system for function, ease of operation and wear.

- Release bearing bracket (1)
- Actuation arm shaft with fork and locking pin (2)
- Lever including bush (3)
- Spring washer (4) standard part

Check and (as appropriate) replace all the other clutch operation parts if faulty or worn.
