GF 380, GF2 / 380, GF 420

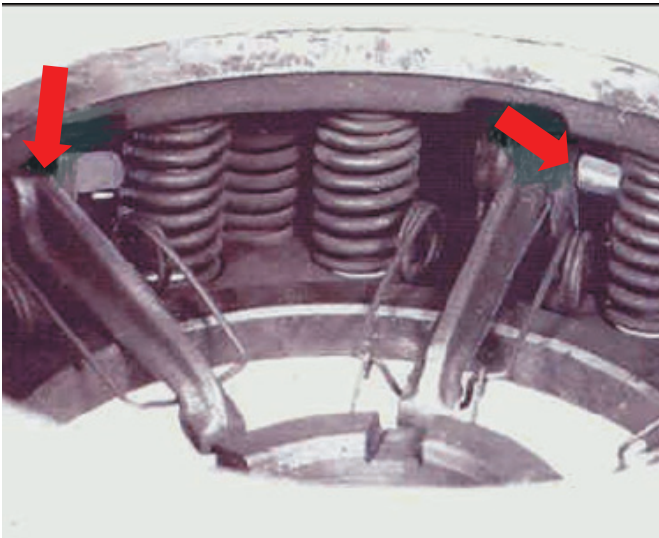
In the above mentioned clutch cover assemblies the cams may rupture. Neither early wear nor a defect in material are the culprit. Root cause of trouble is excessively high torsional engine vibration:

Fig. 1: Inner lever axles worn / pulled away

When you repair clutches with such obvious characteristics in the cover assembly it is absolutely necessary to remedy the root cause of trouble in the engine.

- Engine vibration damper defective
- Considerable pressure difference in the various cylinders
- Injection nozzles drip
- Injection pump defective or incorrectly adjusted

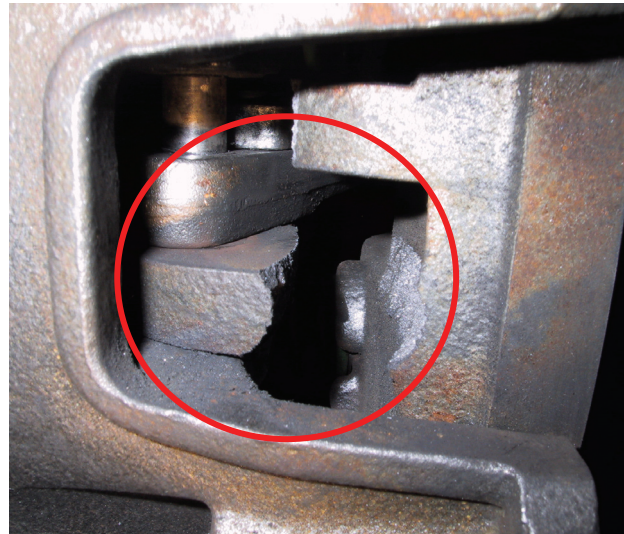
Fig. 2: Guide cam of pressure plate broken
