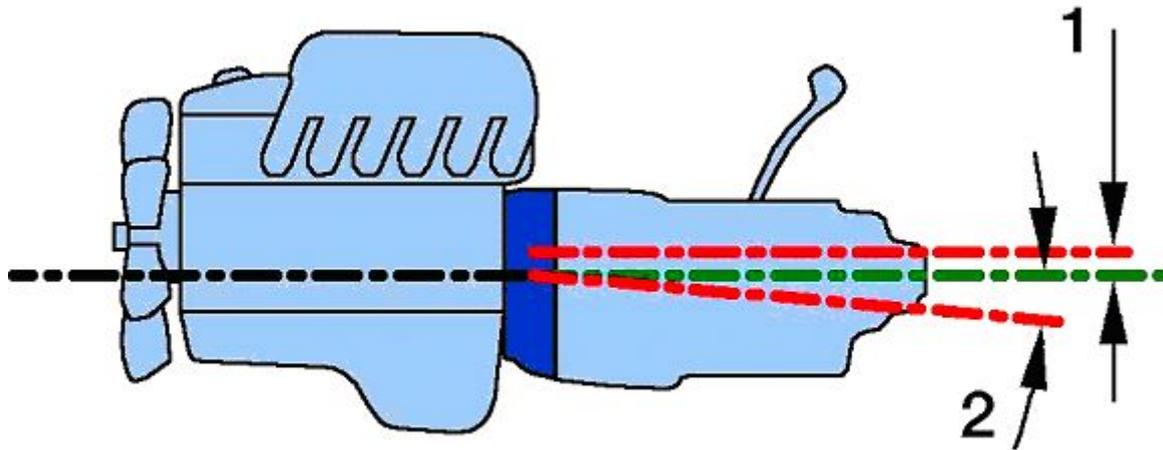
Fig. 1:

Clutch damage is frequently caused by misalignment between the crankshaft and transmission input shaft. Ideally, both shafts have a common center line, i.e. are aligned, when the drive unit is fitted. Alignment errors are deviations from this ideal case. A distinction is made between parallel and angular offset (Fig. 1).

1 Parallel offset

2 Angular offset
