Technical development of clutch discs has led to the linings on some models being attached by adhesives. The modified procedures mean that some of the rivet holes are now empty.

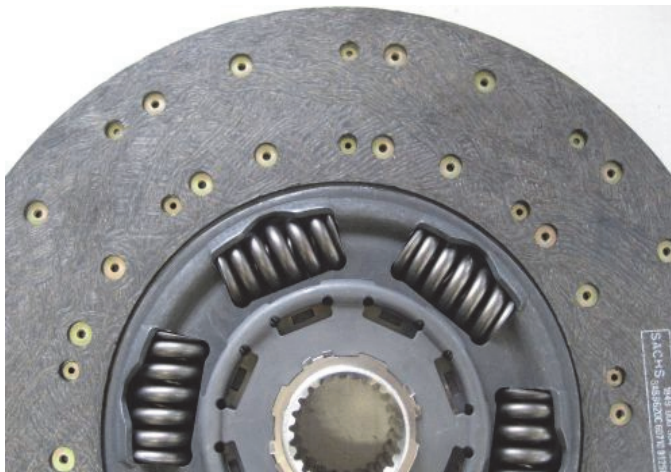
Fig. 3: Lining on the transmission side

The transmission side of the lining (Fig. 3) is first bonded to a carrier panel.

The lining springs are then riveted to the carrier panel.

And then the lining springs are riveted to the driving panel.
