Wheel Cylinder BWD119

Product improvement BWD119

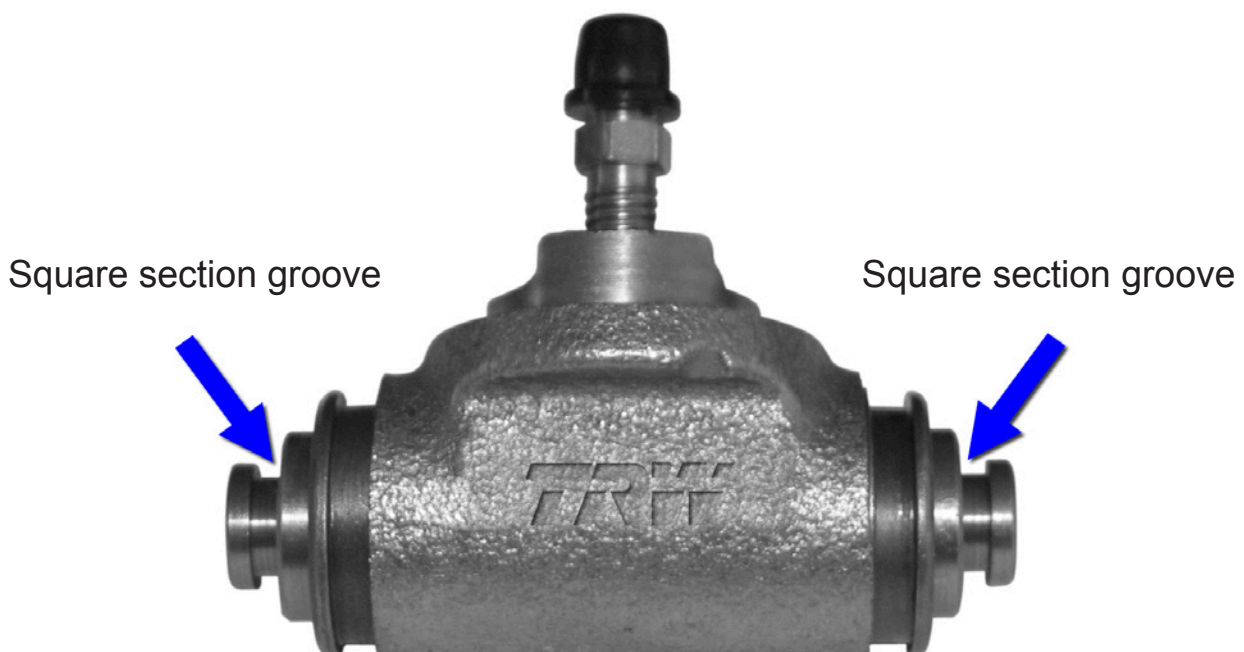
Following regular field service monitoring it has been identified that it may be possible to disturb the location of the wheel cylinder dust covers when replacing Brake Shoes. Incorrect dustcover location can lead to water ingress into the wheel cylinder resulting in corrosion and premature wear / fluid leakage.

To reduce the possibility of this problem occurring and improve the integrity of the assembly, the wheel cylinder pistons now have grooves with a square section for improved dust cover location (see illustration).

„Note: Following brake shoe or wheel cylinder replacement ensure all components are correctly positioned. Pay particular attention to wheel cylinder dust cover location.“
