TRW Service Kit JBJ174

Affected vehicles: Hyundai, Mitsubishi and Volvo

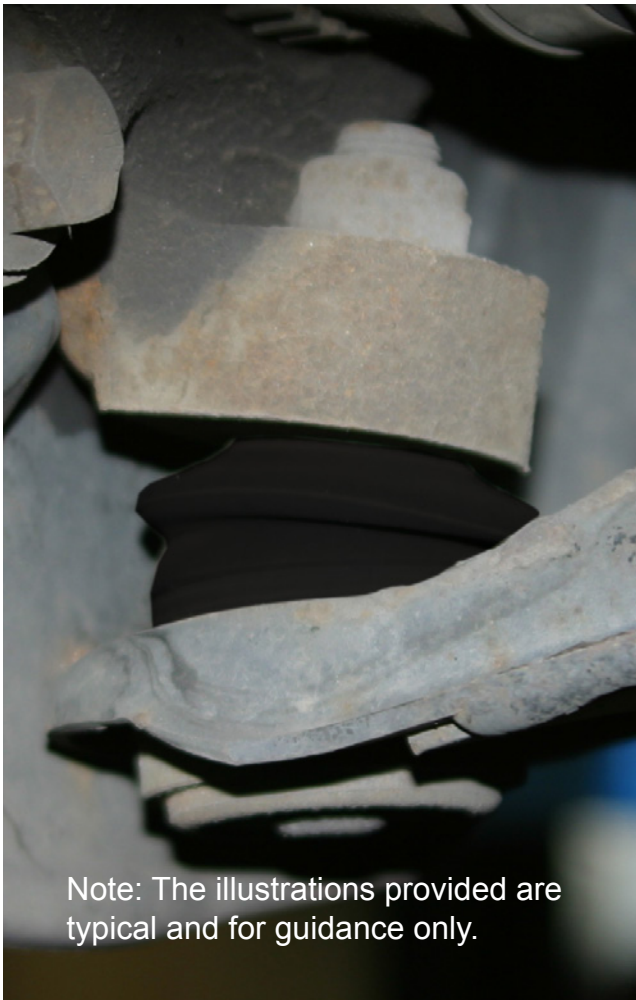
The Service Kit JBJ174 contains a separate dust cover, which is fixed between steering knuckle and track control arm after installation.

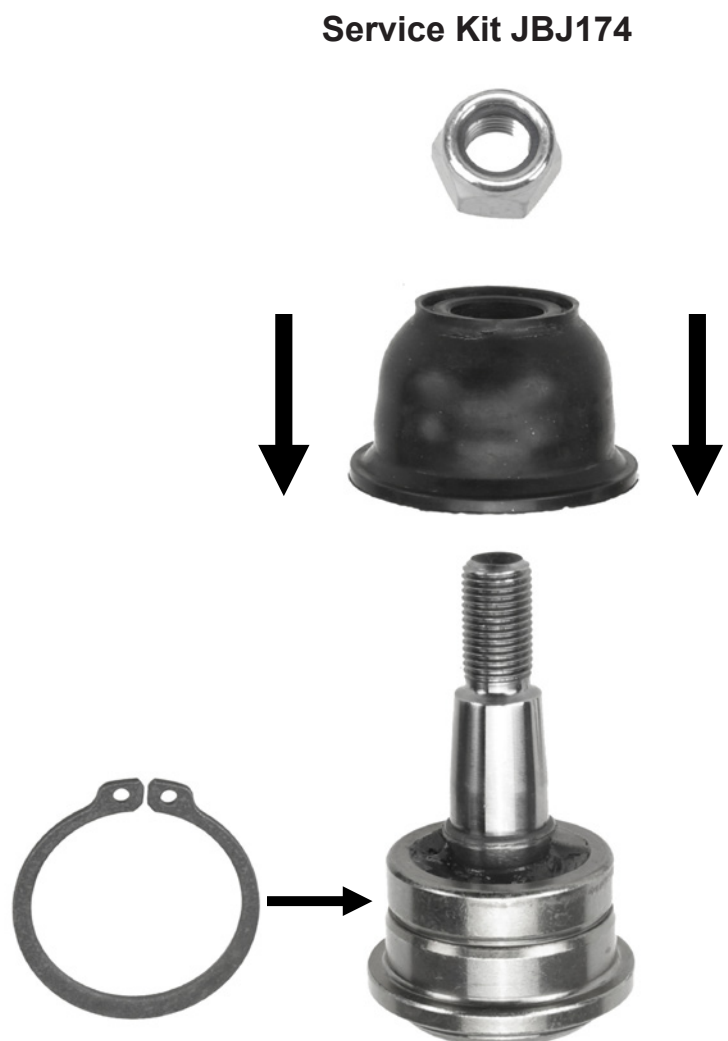
After installation the ball joint must be fixed with the circlip supplied!
