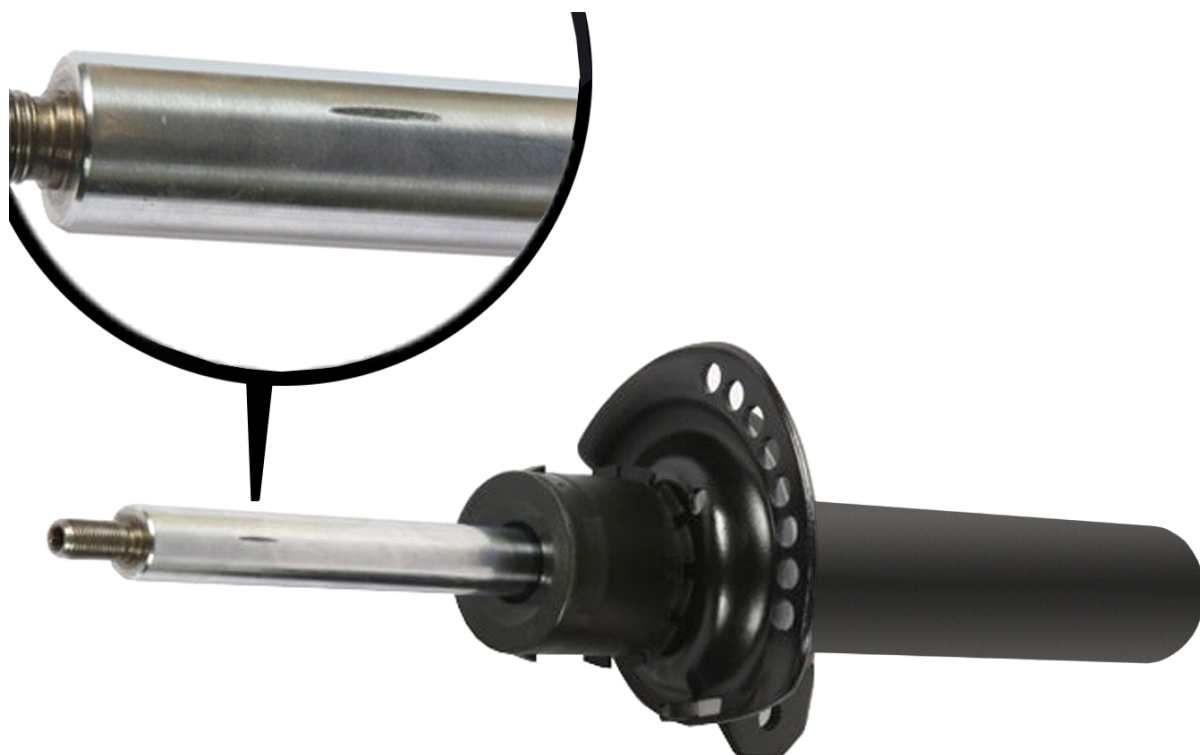
Sl. 1: Stapajica s utomom

U stapajicu je urezan jedan utom zbog proizvodnog postupka (sl. 1). Amortizeri sa ili bez utora (sl. 2) u stapajici, konstrukcijski su isti. Obje izvedbe se mogu ugraditi na istoj osovini.

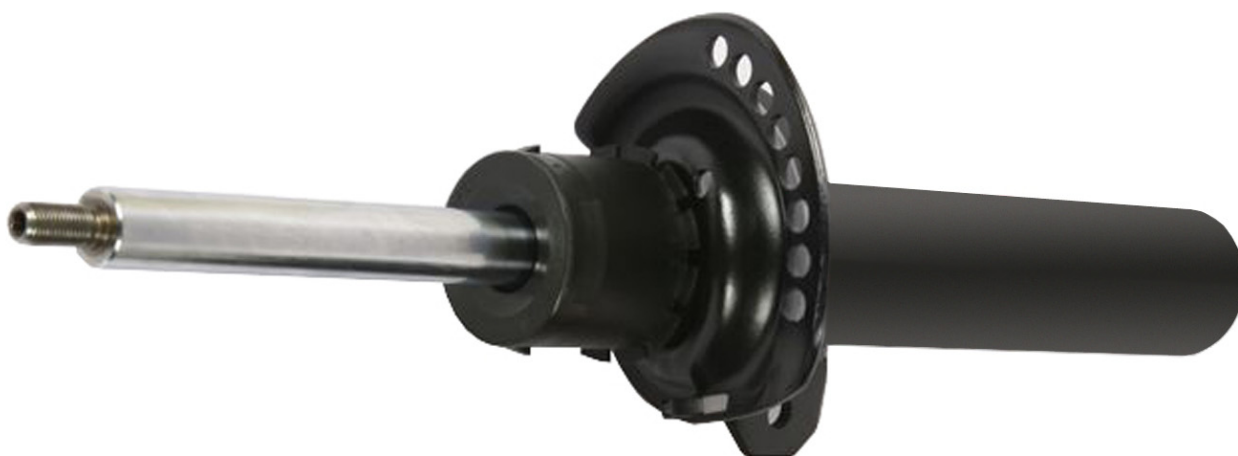
Sl. 2: Stapajica bez utora
