AUDI / SEAT / SKODA / VOLKSWAGEN

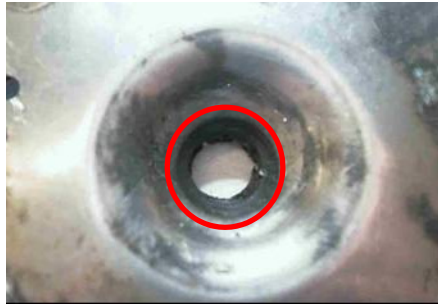
Possible Causes:

- Deteriorated guide of the push rod in the input shaft
- Excessive play of the input shaft bearing
- Another potential cause is a defective release bearing

Consequences:

- Drag
- Noise
- Judder
- Stiff actuation
- Clutch slip

Carefully inspect the described parts when replacing the clutch and renew them if necessary. If signs of eccentric contact caused by the push rod are visible, the described bearings are defective and **must** be replaced.
