Fig. 1:Rubber-to-metal components

Wear of a rubber-to-metal component

Installation of rubber-to-metal components

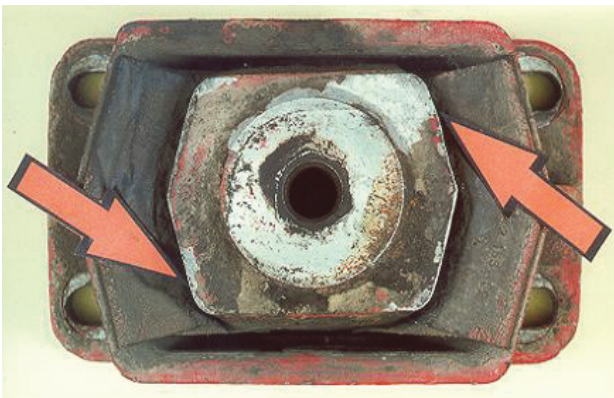
Fig. 2: Wear of a rubber-to-metal component

Rubber-to-metal components are subject to wear and tear as are shock absorbers and tires as a result of:

- continuous, mechanical strain
- environmental impacts e.g. aggressive fluids
- permanent excessive strain e.g. overload
- high temperatures
- material fatigue

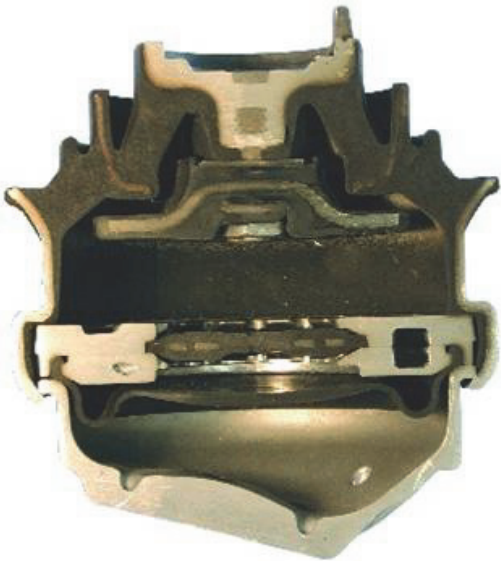
Fig. 3: Original hydraulic part

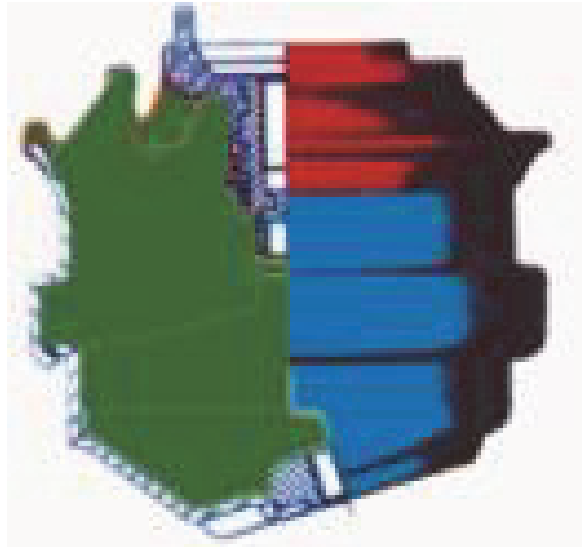
Fig. 4: Full rubber rebuilt

- Original company logos and Ref.-No. are copied i.e. forged.
- the parts correspond to the original parts only optically, thus hydraulic engine mountings from the rebuilders are made as full rubber mountings, without hydraulic fluid, channels, diaphragm and valves.
- Rubber mountings, bushes and silent blocs have an excessive rubber hardness
- The dimensions are not the dimensions of the original part.
- Rubber and metal are not vulcanized, instead they are just glued.

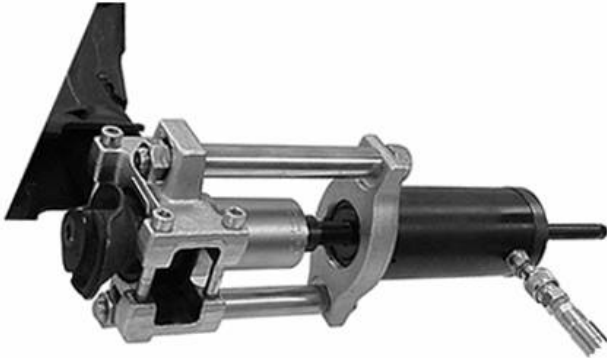
Fig. 5: Press out silent bloc

It is indispensable to use special tools to ensure a time-saving and appropriate installation! When fitting and removing such high-quality components never use welding torch, hammer and chisel, or similar 'auxiliary tools' because their use would cause major defects!

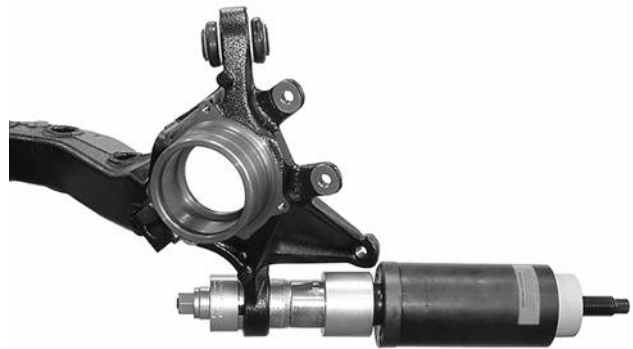
Fig. 6: Insert silent bloc
